**Flood Control Project Maintenance  
Levee Inspections**  
**LMA District Cover Sheet**  
**Spring 2018 Levee Inspection Results**

**Merced Streams Group**

**Flood Control Project Maintenance  
Levee Inspections  
Unit Cover Sheet  
Spring 2018 Levee Inspection Results  
Merced Streams Group**

**Levee Inspection Report By Mile - Spring 2018**

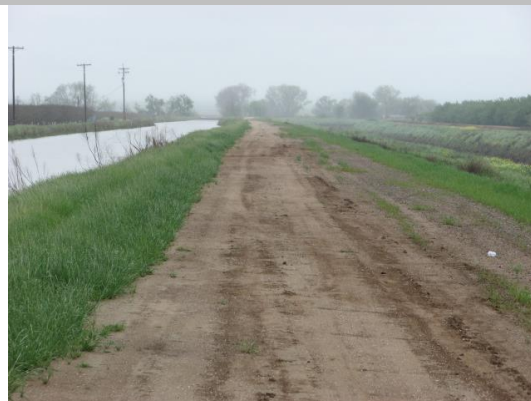
Photo 1 of 1 : SP\_2018\_NA0013\_331\_8\_20180409\_00009.jpg

LM Start	<b>0.27</b>	Rating **	M	Issue No.	<b>8</b>
LM End	<b>1.62</b>	Issue Type +	Ma	Location *	CR
Category	Earthen Levee		GPS Latitude/Longitude		
			Start	End	
Item	Crown Surface / Depressions / Rutting		37.318525 °	37.337176 °	
			-120.396598 °	-120.396531 °	
DWR ID	DWR_NA0013_01_s _ 2018_8				
Comment Code					
C3 : Add appropriate gravel or road base. Grade and compact.					
Inspector Comment

Looking downstream at typical view of levee crown (Spring 2018)

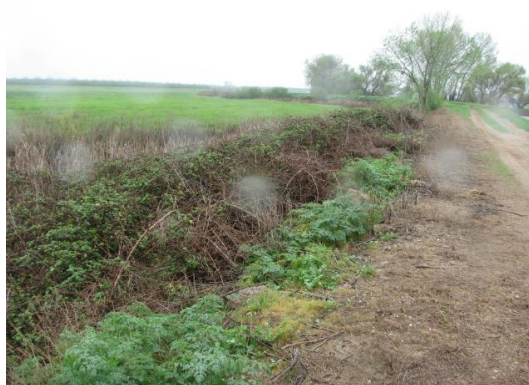
Photo 1 of 2 : SP\_2018\_NA0013\_331\_7\_20180409\_00010.jpg

LM Start	1.57	Rating **	U	Issue No.	7
LM End	1.61	Issue Type +	Ma	Location *	LS
Category	Earthen Levee			GPS Latitude/Longitude	
				Start	End
Item	Vegetation			37.336576 °	37.337098 °
				-120.396540 °	-120.396528 °
DWR ID	DWR_NA0013_01_s_2018_7				
Comment Code					
V2 : Remove the wild growth other than native grasses from the levee slopes.					
Inspector Comment					
Remove wildroses from landward slope.

Looking downstream at wildroses on landward slope. (Spring 2018)

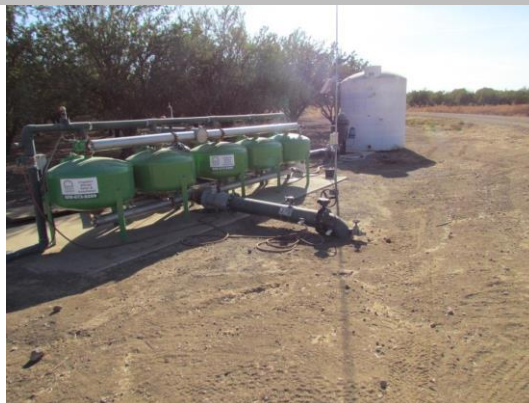
Photo 2 of 3 : SP\_2018\_NA0013\_332\_2\_20180307\_00002.jpg

No Permit for this filtration system and tank on the easement. 2016

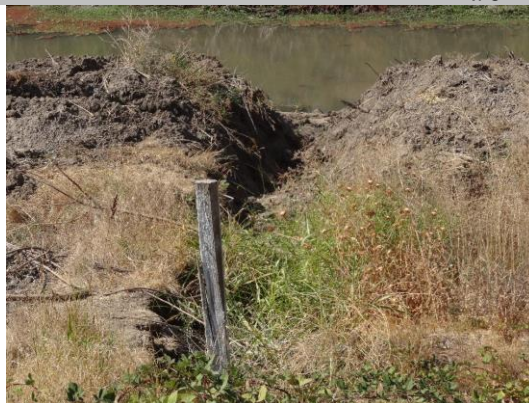
Photo 1 of 3 : UCIP\_SP\_2018\_50156\_35245.jpg

Comment Code					
Inspector Comment					
FS_ID:50156 DS_ID:23053 EP_NO: N/A Repair Type: No Action Needed Crossing Status: Found UCIP Comments: 08/23/2016: LS inlet is clear. WS gate has been cleared of vegetation and functions properly. Crossing has been downgraded from Urgent to No Action Needed. (K. Fazel - UCIP)09/17/2013:- needs vegetation cleaning on both sides.- flap gate was not closed during field survey.- inlet needs cleaning. (P. Amatya - UCIP) FIELD_STRUCT_DESC: 24-inch corrugated metal gravity drainage pipe through the levee, 8 feet below the crown. Concrete headwall, flap gate, and concrete grouted cobble spillway on the waterside (WS) toe. Concrete headwall on the landside (LS) toe. [Additional Reference(s): DWR Levee Log, 2005. USACE San Joaquin O&M Manual 607, June 1962, (HLM 0.29)]. FS Date: 8/23/2016

WS view: cobble spillway and channel on waterside.

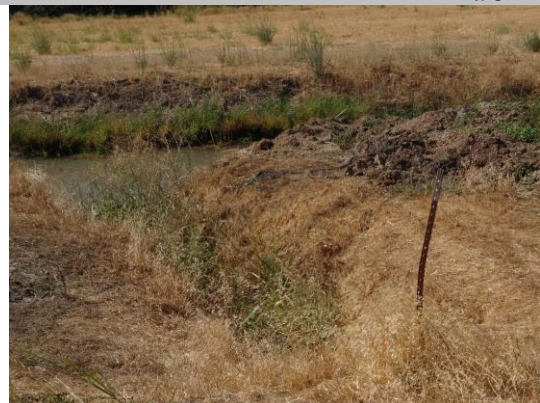
Photo 1 of 3 : UCIP\_SP\_2018\_20946\_35266.jpg

LM Start	0.54	Rating **	M	Issue No.	27
LM End	0.54	Issue Type +	Ma	Location *	
Category	Supplemental			GPS Latitude/Longitude	
				Start	End
Item	DWR UCIP LMA Responsibility			37.333180 °	37.333180 °
				-120.394069 °	-120.394069 °
DWR ID					
Comment Code					
Inspector Comment					
FS_ID:20946 DS_ID:23054 EP_NO: N/A Repair Type: Non-Urgent Crossing Status: Found UCIP Comments: - needs vegetation cleaning on both sides.- flap gate was not properly closed during field survey.- inlet needs cleaning. FIELD_STRUCT_DESC: 24-inch corrugated metal gravity drainage pipe through the levee, 12 feet below the crown. Concrete headwall, flap gate, and concrete grouted cobble spillway on the waterside (WS) toe. Concrete headwall on the landside (LS) toe. [Additional Reference(s): DWR Levee Log, 2005]. FS Date: 9/17/2013

WS view: cobble spillway and channel on waterside.

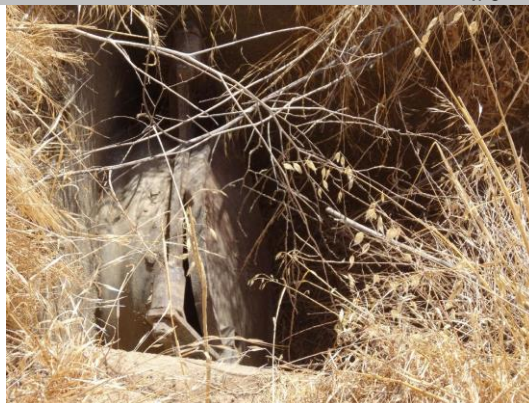
Photo 2 of 3 : UCIP\_SP\_2018\_20946\_35265.jpg

LM Start	0.54	Rating **	M	Issue No.	27 (cont)	
LM End	0.54	Issue Type +	Ma	Location *		
Category	Supplemental			GPS Latitude/Longitude		
				Start	End	
Item	DWR UCIP LMA Responsibility			37.333180 °	37.333180 °	
				-120.394069 °	-120.394069 °	
DWR ID						
Comment Code						
Inspector Comment						
FS_ID:20946 DS_ID:23054 EP_NO: N/A Repair Type: Non-Urgent Crossing Status: Found UCIP Comments: - needs vegetation cleaning on both sides.- flap gate was not properly closed during field survey.- inlet needs cleaning. FIELD_STRUCT_DESC: 24-inch corrugated metal gravity drainage pipe through the levee, 12 feet below the crown. Concrete headwall, flap gate, and concrete grouted cobble spillway on the waterside (WS) toe. Concrete headwall on the landside (LS) toe. [Additional Reference(s): DWR Levee Log, 2005]. FS Date: 9/17/2013

WS view: U typed concrete headwall, CM pipe, and flap gate. Flap gate was not properly closed.

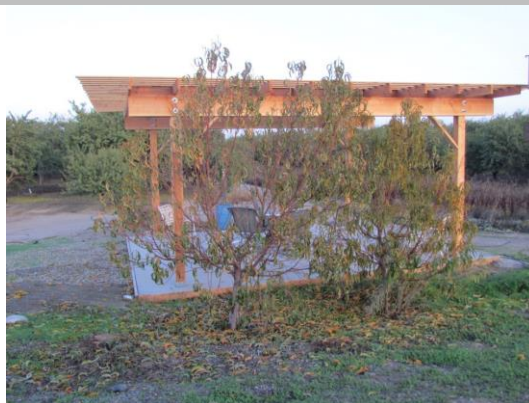
Photo 2 of 4 : SP\_2018\_NA0013\_332\_24\_20180307\_00009.jpg

LM Start	0.88	Rating **	U	Issue No.	24 (cont)
LM End	0.88	Issue Type +	En	Location *	LS
Category	Earthen Levee			GPS Latitude/Longitude	
				Start	End
Item	Encroachments			37.328567 °	37.328567 °
				-120.396062 °	-120.396062 °
DWR ID	DWR_NA0013_02_s_2014_24				
Comment Code					
TR : Tree or limb					
Inspector Comment					
Three fruit trees with irrigation system, stock pile of material (2) piles on the land side toe and rock pad placed on land side toe. Discovered during the fall 2014 inspection a structure has been installed on the landward levee slope and berm. No permit for these encroachments.

Another view of unauthorized structure.

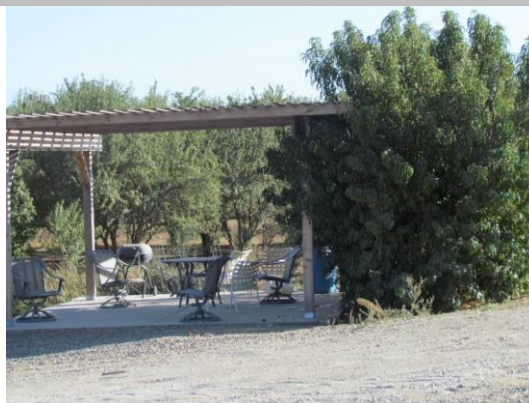
Photo 3 of 4 : SP\_2018\_NA0013\_332\_24\_20180307\_00010.jpg

Unit 2 looking downstream from levee mile 0.88.

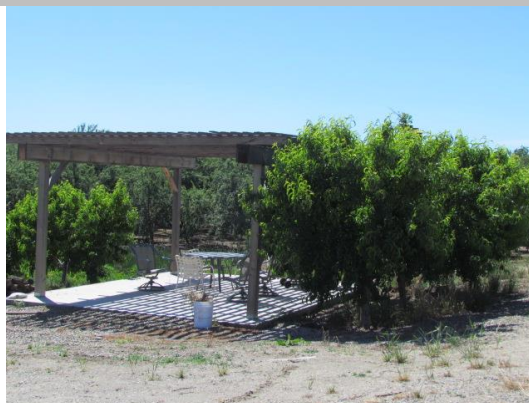
Photo 4 of 4 : SP\_2018\_NA0013\_332\_24\_20180307\_00011.jpg

No change 5-2017.

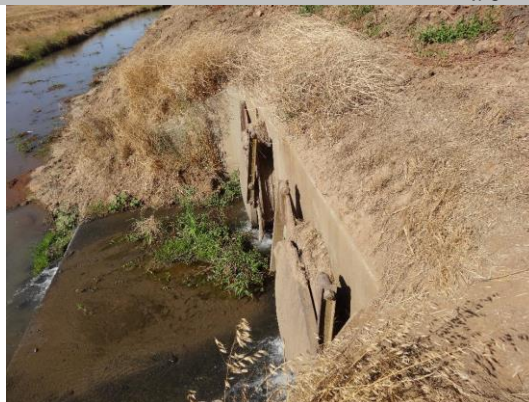
Photo 1 of 3 : UCIP\_SP\_2018\_20983\_35302.jpg

LM Start	0.91	Rating **	A/W	Issue No.	30
LM End	0.91	Issue Type +	Ma	Location *	
Category	Supplemental			GPS Latitude/Longitude	
				Start	End
Item	DWR UCIP LMA Responsibility			37.328267 °	37.328267 °
				-120.396084 °	-120.396084 °
DWR ID					
Comment Code					
Inspector Comment					
FS_ID:20983 DS_ID:23080 EP_NO: N/A Repair Type: No Action Needed Crossing Status: Found UCIP Comments: It was working during field inspection. Dense vegetation in drainage ditch. FIELD_STRUCT_DESC: 2 of 2: 60-inch corrugated metal gravity drainage pipe through the levee, 10 feet below the crown. Concrete headwall and flap gate on the waterside (WS) berm, 5 feet from the levee toe. Concrete headwall on the landside (LS) toe. [Additional Reference(s): DWR Levee Log, 2005. USACE San Joaquin O&M Manual 607, June 1962, (HLM 0.91)]. FS Date: 9/17/2013

WS view: two CMPs with flap gate, concrete spillway and channel on waterside.

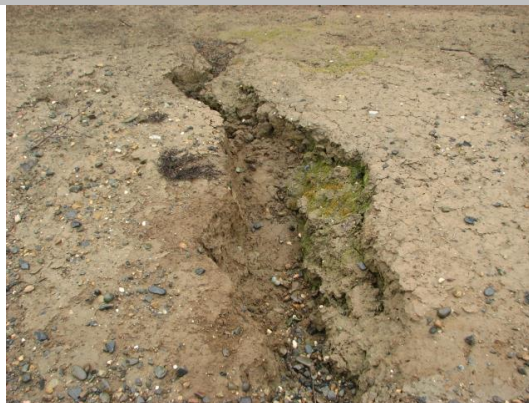
Photo 1 of 2 : SP\_2018\_NA0013\_332\_15\_20180409\_00036.jpg

LM Start	0.97	Rating **	M	Issue No.	15
LM End	0.97	Issue Type +	Ma	Location *	LS
Category	Earthen Levee			GPS Latitude/Longitude	
				Start	End
Item	Erosion / Bank Caving			37.327336 °	37.327336 °
				-120.396085 °	-120.396085 °
DWR ID	DWR_NA0013_02_f_2017_15				
Comment Code					
E1 : Note and monitor erosion site.					
Inspector Comment					
Large finger erosion on landward slope.

Looking east at finger erosion on landward slope. (Spring 2018)

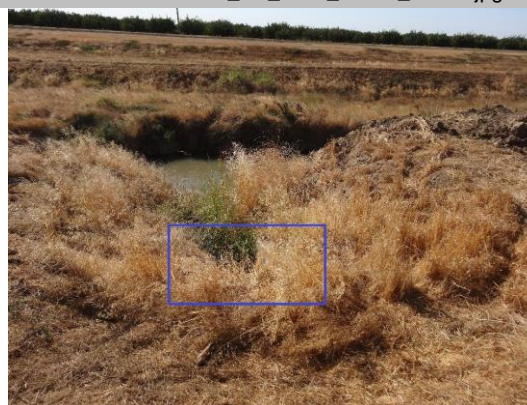
Photo 1 of 3 : UCIP\_SP\_2018\_20984\_35305.jpg

LM Start	1.30	Rating **	A/W	Issue No.	31
LM End	1.30	Issue Type +	Ma	Location *	
Category	Supplemental			GPS Latitude/Longitude	
				Start	End
Item	DWR UCIP LMA Responsibility			37.322499 °	37.322499 °
				-120.396045 °	-120.396045 °
DWR ID					
Comment Code					
Inspector Comment					
FS_ID:20984					
DS_ID:23057					
EP_NO: N/A					
Repair Type: No Action Needed					
Crossing Status: Found					
UCIP Comments: - working during field inspection.					
FIELD_STRUCT_DESC: 24-inch corrugated metal gravity drainage pipe through the levee, 10 feet below the crown. Concrete headwall, flap gate, and concrete grouted cobble spillway on the waterside (WS) toe. Concrete headwall on the landside (LS) toe. [Additional Reference(s): DWR Levee Log, 2005. USACE San Joaquin O&M Manual 607, June 1962, (HLM 1.32)].					
FS Date: 9/17/2013

WS view: U type concrete headwall and channel on waterside.

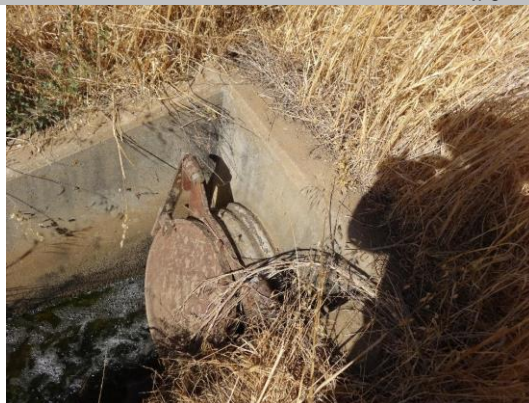
Photo 2 of 3 : UCIP\_SP\_2018\_20984\_35304.jpg

WS view: U typed concrete headwall, CM pipe, and flap gate. It was working during field inspection.

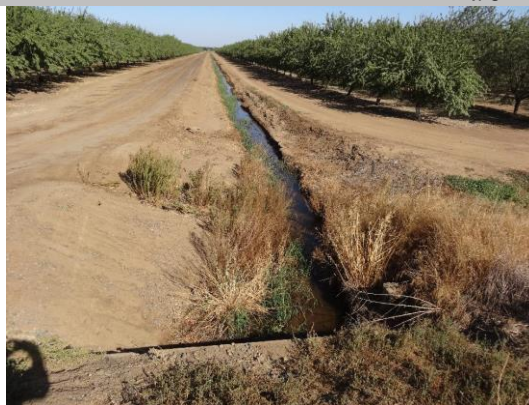
Photo 3 of 3 : UCIP\_SP\_2018\_20984\_35303.jpg

LS view: concrete headwall on levee toe and drainage ditch.

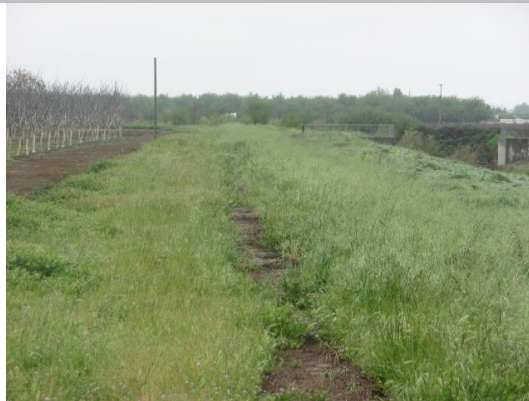
Photo 1 of 1 : SP\_2018\_NA0013\_332\_17\_20180409\_00038.jpg

LM Start	1.62	Rating **	U	Issue No.	17
LM End	1.85	Issue Type +	Ma	Location *	CR
Category	Earthen Levee			GPS Latitude/Longitude	
				Start	End
Item	Vegetation			37.317882 °	37.314609 °
				-120.395718 °	-120.395807 °
DWR ID	DWR_NA0013_02_s_2017_17				
Comment Code					
V9 : Keep the crown roadway free of vegetation.					
Inspector Comment					
Mowe to allow visibility and access.

Looking downstream at levee crown. (Spring 2018)

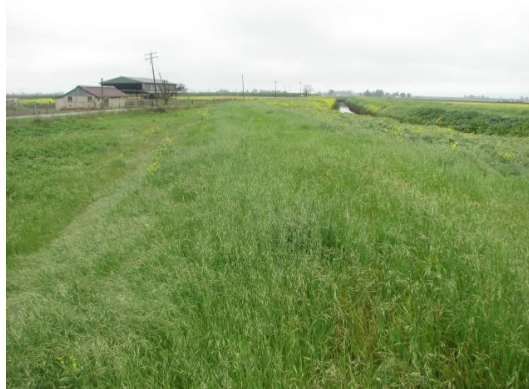
Photo 1 of 1 : SP\_2018\_NA0013\_333\_13\_20180409\_00027.jpg

LM Start	0.00	Rating **	U	Issue No.	13
LM End	0.43	Issue Type +	Ma	Location *	CR
Category	Earthen Levee			GPS Latitude/Longitude	
				Start	End
Item	Vegetation			37.257775 °	37.263795 °
				-120.288640 °	-120.288442 °
DWR ID	DWR_NA0013_03_s_2017_13				
Comment Code					
V2 : Remove the wild growth other than native grasses from the levee slopes.					
Inspector Comment					
Control wild growth on levee crown

Looking upstream at overgrown levee crown. (Spring 2018)

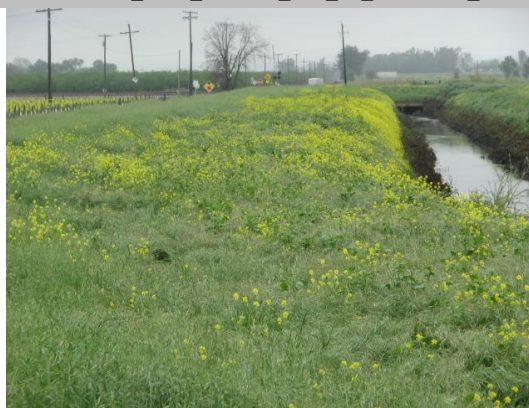
Photo 1 of 3 : SP\_2018\_NA0013\_333\_12\_20180409\_00028.jpg

LM Start	0.00	Rating **	U	Issue No.	12
LM End	0.43	Issue Type +	Ma	Location *	WS
Category	Earthen Levee			GPS Latitude/Longitude	
				Start	End
Item	Vegetation			37.257775 °	37.263796 °
				-120.288640 °	-120.288442 °
DWR ID	DWR_NA0013_03_s_2017_12				
Comment Code					
V2 : Remove the wild growth other than native grasses from the levee slopes.					
Inspector Comment					
Control wild growth on levee slope

Looking upstream at waterward slope. (Spring 2018)

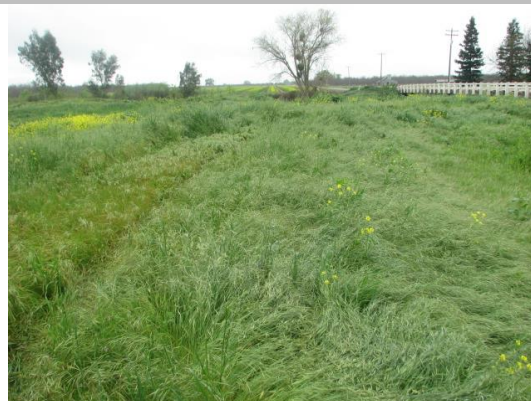
Photo 1 of 1 : SP\_2018\_NA0013\_333\_10\_20180409\_00029.jpg

LM Start	0.03	Rating **	U	Issue No.	10
LM End	0.43	Issue Type +	Ma	Location *	LS
Category	Earthen Levee			GPS Latitude/Longitude	
				Start	End
Item	Vegetation			37.258000 °	37.263796 °
				-120.288379 °	-120.288442 °
DWR ID	DWR_NA0013_03_s_2018_10				
Comment Code					
V2 : Remove the wild growth other than native grasses from the levee slopes.					
Inspector Comment

Looking downstream at landward slope. (Spring 2018)

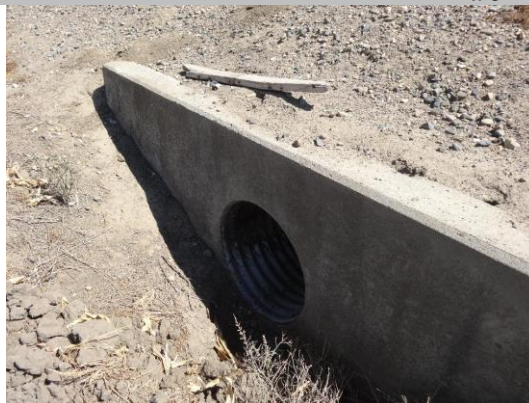
Photo 3 of 3 : UCIP\_SP\_2018\_50151\_35541.jpg

Comment Code						
Inspector Comment						
FS_ID:50151 DS_ID:23063 EP_NO: N/A Repair Type: No Action Needed Crossing Status: Found UCIP Comments: 09/2016: LS and WS ends have been cleared by NA0013 and crossing has been downgraded to No Action Needed. (K. Fazel - UCIP)09/2013: Needs vegetation clearing on WS. (P. Amatya - UCIP) FIELD_STRUCT_DESC: 24-inch corrugated metal gravity drainage pipe through the levee, 6.5 feet below the crown. Concrete headwall, flap gate, and concrete grouted cobble spillway on the waterside (WS) toe. Concrete headwall on the landside (LS) toe. [Additional Reference(s): DWR Levee Log, 2005. USACE San Joaquin O&M Manual 607, June 1962, (HLM 0.80), referenced as 10 feet below the crown]. FS Date: 9/7/2016

LS view: concrete headwall and CM pipe.

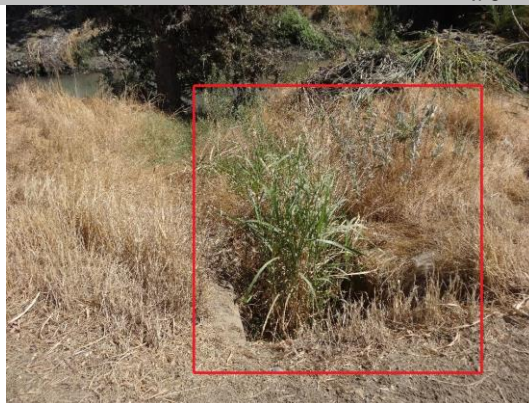
Photo 1 of 3 : UCIP\_SP\_2018\_21064\_35506.jpg

Comment Code					
Inspector Comment					
FS_ID:21064					
DS_ID:23066					
EP_NO: N/A					
Repair Type: Non-Urgent					
Crossing Status: Found					
UCIP Comments: - needs clearing and cleaning of vegetations on both ends of the pipe.- needs clearing and cleaning of silt deposited inside of the pipe.					
FIELD_STRUCT_DESC: 24-inch corrugated metal gravity drainage pipe through the levee, 4 feet below the crown. Concrete headwall, flap gate, and concrete grouted cobble spillway on the waterside (WS) toe. Concrete headwall on the landside (LS) toe. [Additional Reference(s): DWR Levee Log, 2005. USACE San Joaquin O&M Manual 607, June 1962, (HLM 1.29)].					
FS Date: 9/17/2013

WS view: cobble spillway and channel on waterside. Dense vegetation on levee slope and spillway.

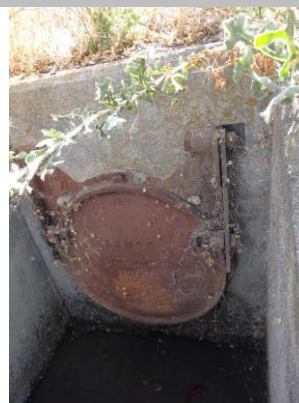
Photo 2 of 3 : UCIP\_SP\_2018\_50148\_35612.jpg

WS view: U typed concrete headwall, CM pipe, and flap gate.

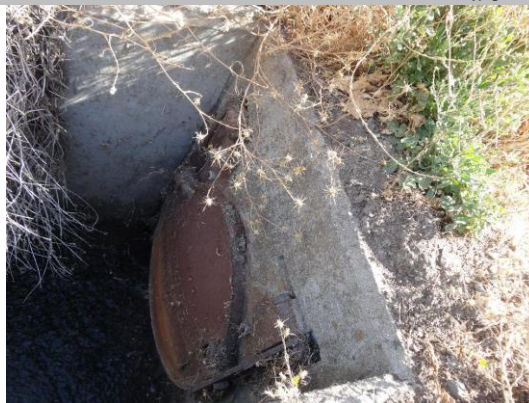
Photo 2 of 3 : UCIP\_SP\_2018\_21126\_35651.jpg

WS view: U typed concrete headwall, CM pipe, and flap gate. Vegetation needs to be cleared on spillway.

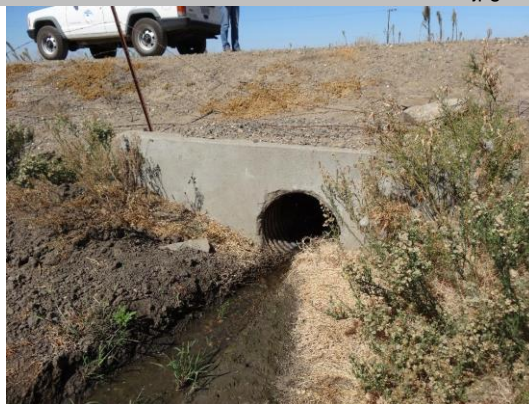
Photo 3 of 3 : UCIP\_SP\_2018\_21126\_35654.jpg

LS view: concrete headwall and CM pipe. Drain pipe was working during field survey.

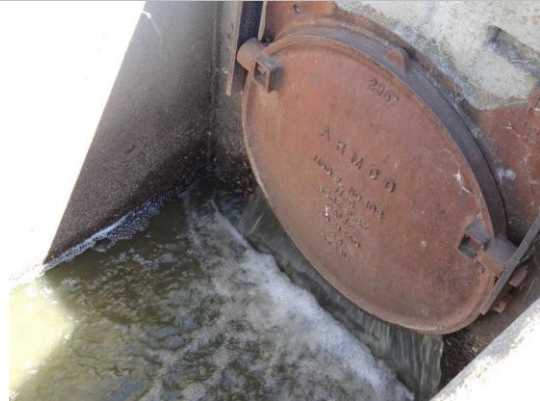
Photo 3 of 3 : UCIP\_SP\_2018\_21127\_35655.jpg

LM Start	1.01	Rating **	A/W	Issue No.	21 (cont)
LM End	1.01	Issue Type +	Ma	Location *	
Category	Supplemental			GPS Latitude/Longitude	
				Start	End
Item	DWR UCIP LMA Responsibility			37.263139°	37.263139°
				-120.287799°	-120.287799°
DWR ID					
Comment Code					
Inspector Comment					
FS_ID:21127					
DS_ID:23074					
EP_NO: N/A					
Repair Type: No Action Needed					
Crossing Status: Found					
UCIP Comments: - concrete spillway on waterside.- drainage was working during field survey.					
FIELD_STRUCT_DESC: 24-inch corrugated metal gravity drainage pipe through the levee, 8 feet below the crown. Concrete headwall, flap gate, and concrete grouted cobble spillway on the waterside (WS) toe.					
Concrete headwall on the landside (LS) toe. [Additional Reference(s): DWR Levee Log, 2005. USACE San Joaquin O&M Manual 607, June 1962, (HLM 1.02)].					
FS Date: 9/17/2013

WS view: U typed concrete headwall, CM pipe, and flap gate. Drainage was working during survey.
